**Subject:** DPR Aquatics Splash and Play – Wheels Skating Rink Assessment

Project Name: Wheel of Fun Durham Aquatics Code Findings

Mechanical, Electrical, Plumbing & Fire Protection  
Needed/Recommended Actions to Keep Skating Rink Open  
June 16, 2022 – updated Aug. 23, 2022

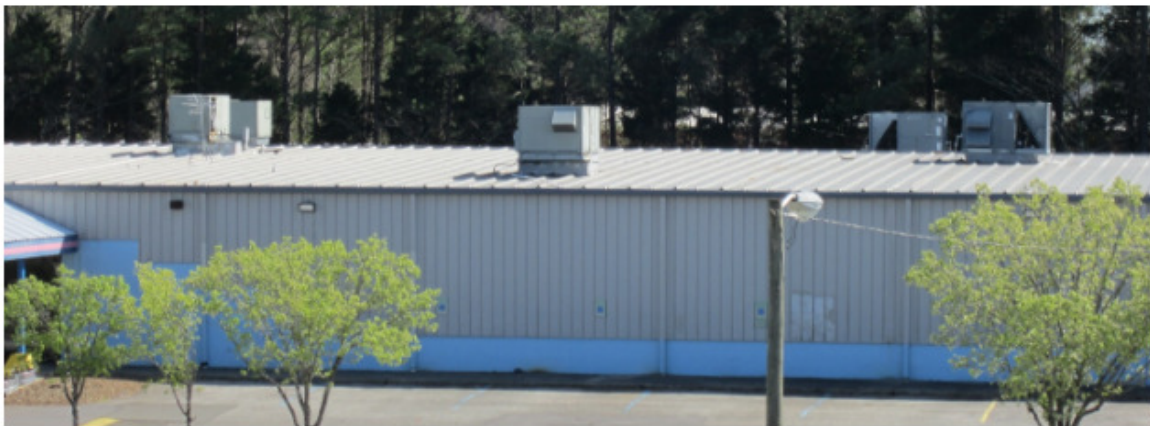
1. RTU#1 was iced up at the time of the site visit.
2. RTU#2 does not have heating capability.

*Skate Center RTUs (Photo taken from roof of Play Structure)*

- The Trane units (RTU#1 and RTU#5) are in poor condition and have reached their expected useful life.
- Trane unit RTU#2 is 13 years old and nearing the end of its expected useful life.
- The Daikin units (RTU#3 and RTU#4) are 8 years old, in fair condition, and expected to have a remaining useful life of 5 to 10 years with normal maintenance performed on a regular basis.
